# Manhole Inspection Summary

Manhole # S31II1019MH

**Location** Address: **OAK PL**

Cross Street: **CHARLES ST**

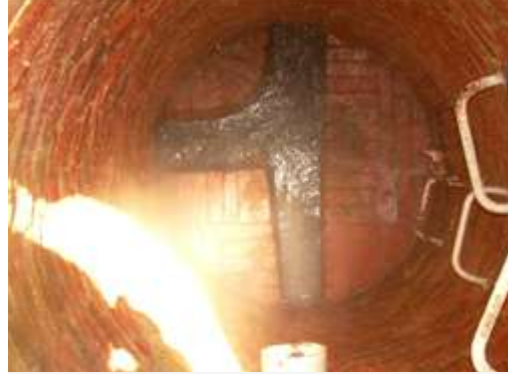
Top View

Corroded steps. Evidence of surcharge - Bench debris.

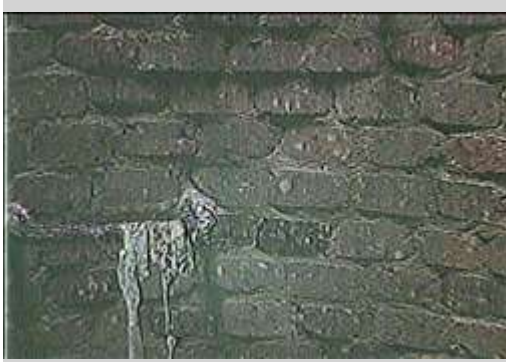
Evidence of surcharge

☒ **Evidence Of Surcharge**

Depth: **3** (ft.) ☐ Active Surcharge Present

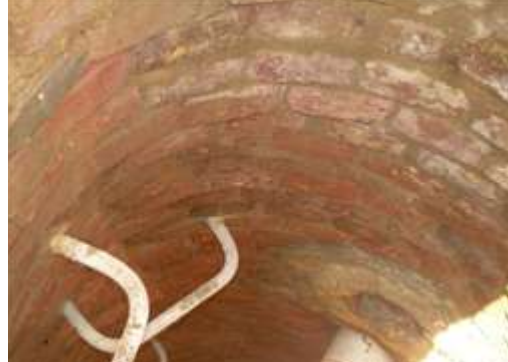
Defect

Infiltration: ☐ None ☒ **Joint** ☐ Cracks ☐ Mortar ☐ Roots ☒ **Wall**

Condition: ☐ Sound ☐ Cracked ☐ Root Intrusion ☐ Loose Brick ☒ **Deteriorated**

Infiltration: ☐ None ☐ Joint ☐ Cracks ☒ **Mortar** ☐ Roots ☐ Wall

Corbel and Barrel infiltration.

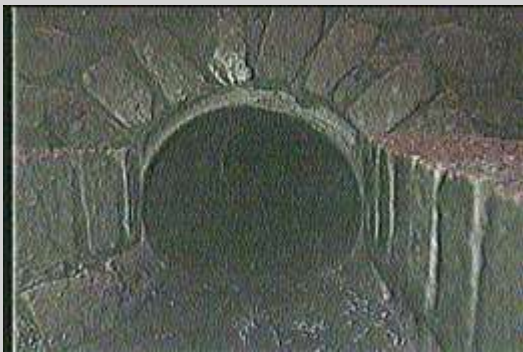
### 10 in. Circular Gravity Sewer Pipe Out @ 12 O'Clock

Infiltration: **Evidence** Pipe Seal Cond: **Cracked**

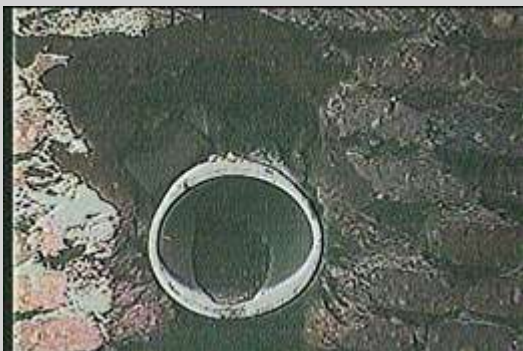
### 6 in. Circular Gravity Sewer Pipe In @ 6 O'Clock

Infiltration: **Evidence** Pipe Seal Cond: **Cracked**

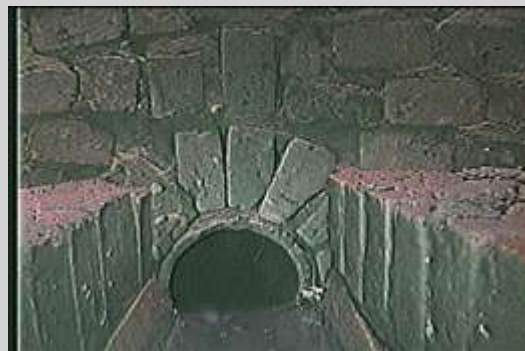
### Drop In @ 6 O'Clock

Condition: ☐ Sound ☐ Cracked ☐ Root Intrusion ☒ **Deteriorated** ☐ Leaks ☐ Debris

Barrel deterioration and infiltration. Channel deterioration.
